CERTS MICROGRID LABORATORY TEST BED

Test Plan Section 7.0
Validate Protection Settings and
Initial Fault Testing

Prepared By:
Lawrence Berkeley National Laboratory

SECTION 7.0

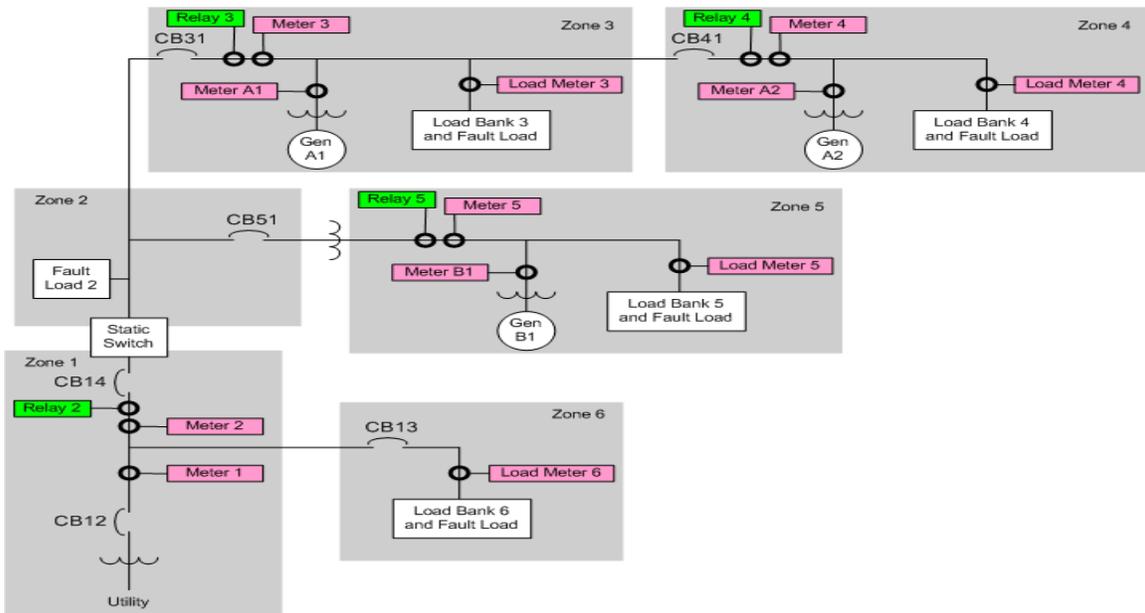
Figure 3 - Simplified diagram of Test Bed showing Meter and Relay locations

There are twelve PML ION 7650 meters placed through out the microgrid and shown in Figure 3, which monitor electrical system conditions, plus acquire phase current and voltage waveforms; and calculate RMS values of voltage, current, active power, reactive power, and frequency.

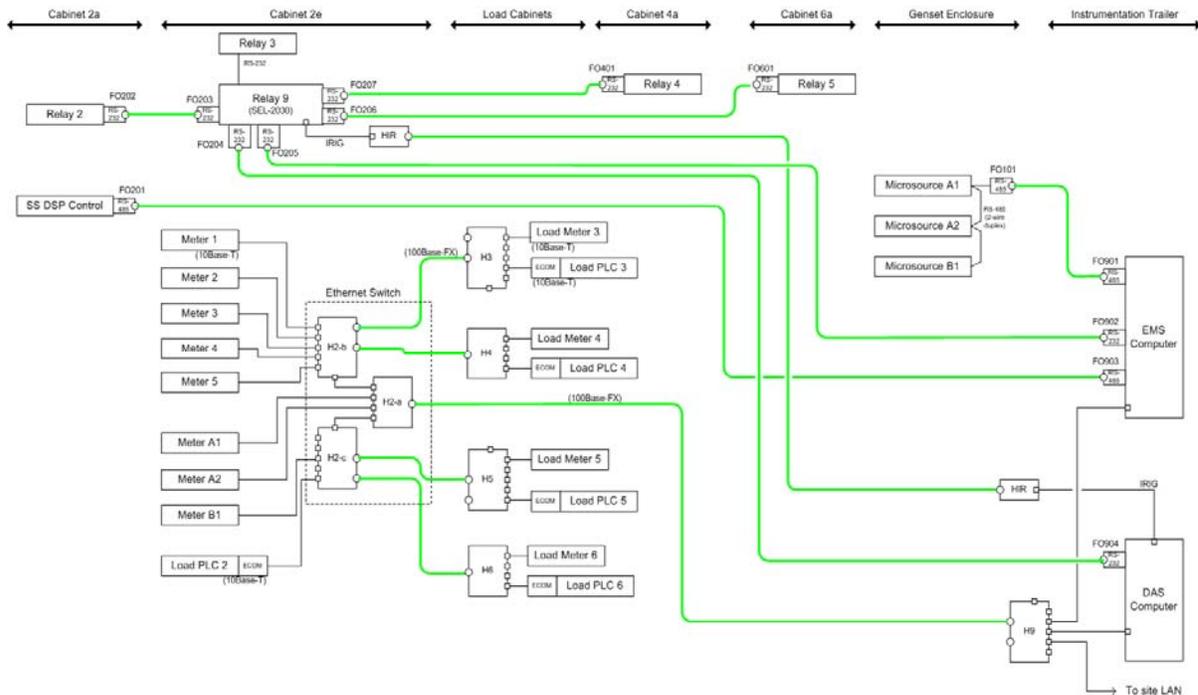
Figure 4 - Diagram of DAS & EMS Data networks

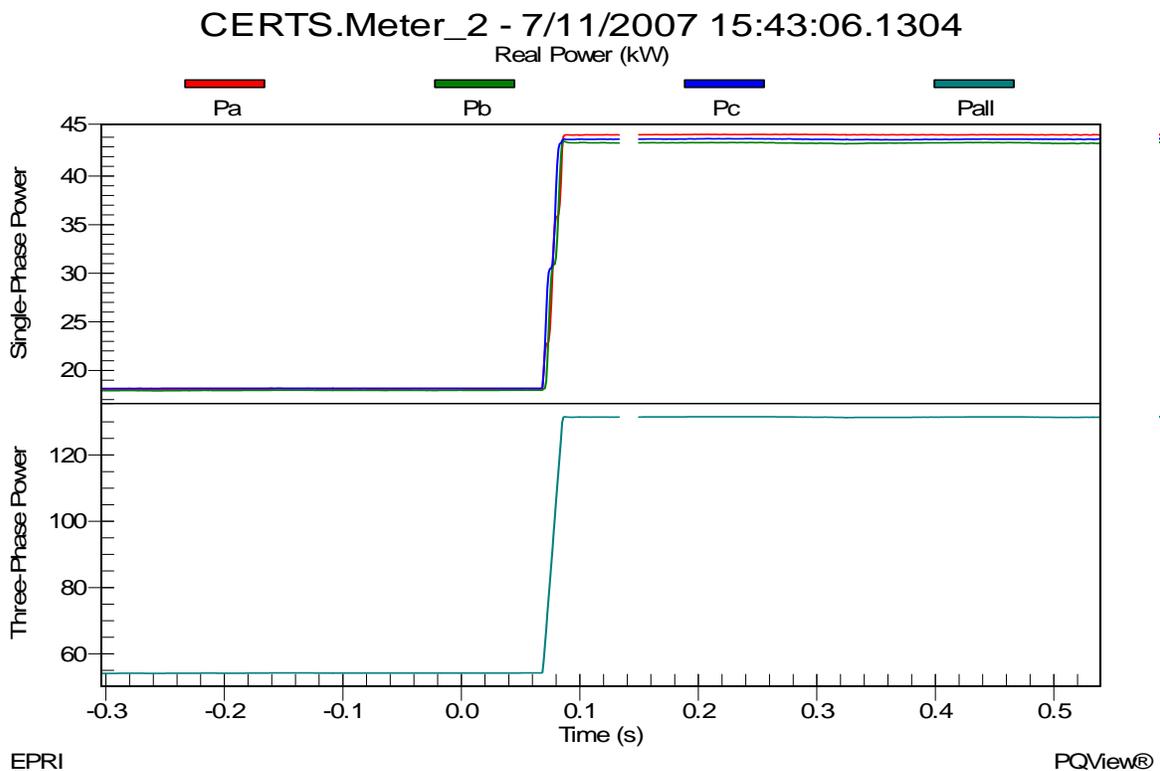
Figure 10a - Load in Zone 4 when the overload fault is initiated

Bed was connected to the utility grid with approximately 55kW at Meter 2. A simulated fault (i.e., Overload Load Bank of 85kW) with a duration set for 99 seconds was initiated to Zone 4 from the DAS Load Control Program. Figure 10a shows when the overload bank was initiated and the load in Zone 4 increased from approximately 55kW to 130kW.

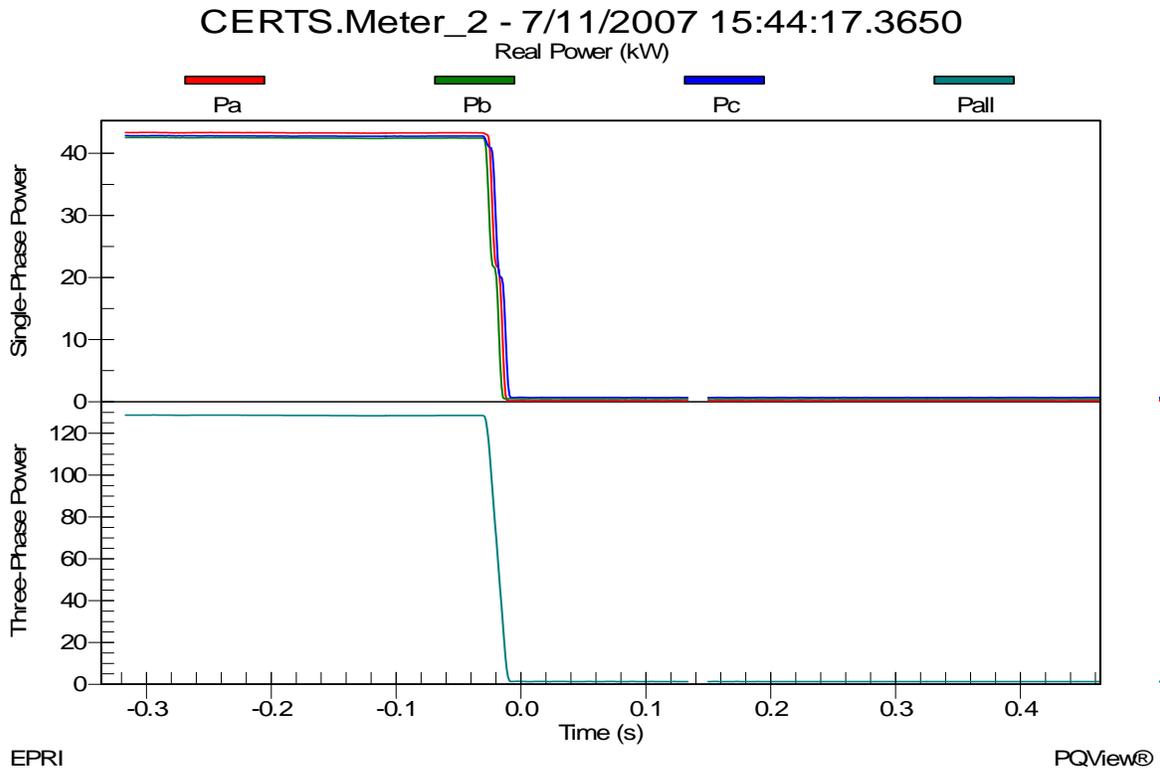
Figure 10b - Load in Zone 4 after circuit breaker CB41 "Opens" to isolate and clear the fault

When the load increased in Zone 4, CB41 internally detected an I²t protection event and opened after 71.3 seconds, clearing the fault from Zone 4, shown in Figure 10b.

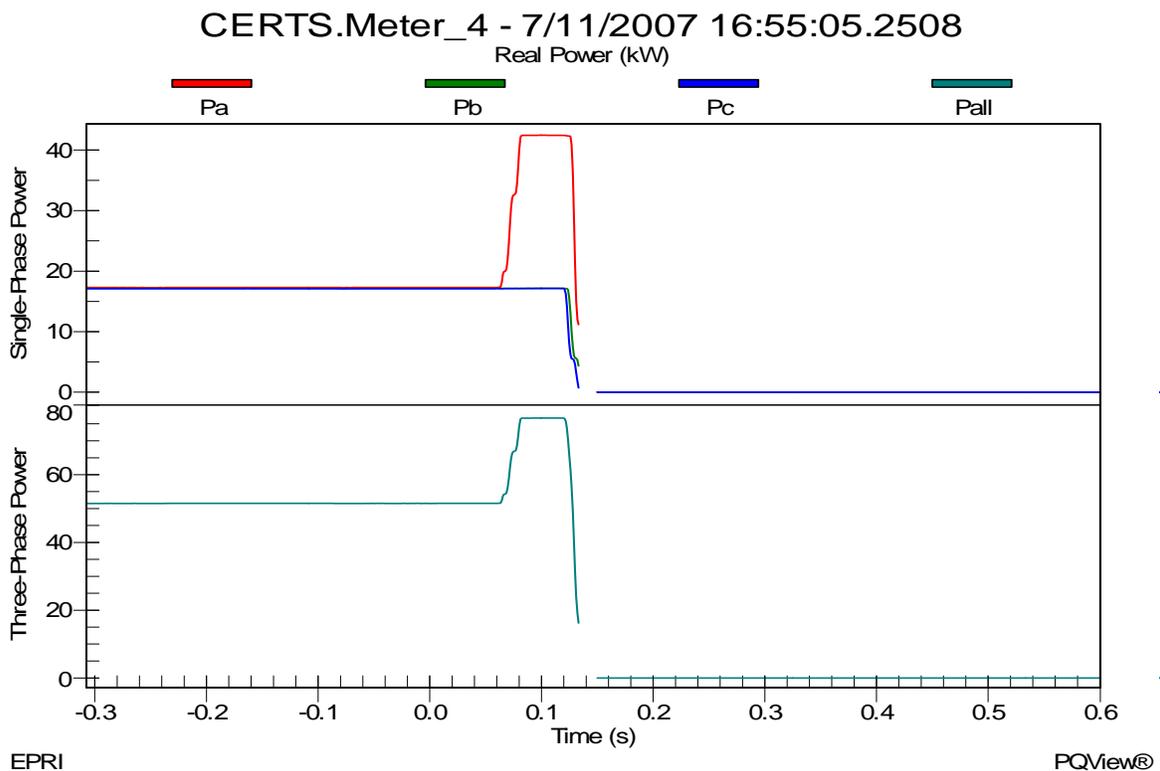
Figure 10d - Load in Zone 4 before/after the single phase-to-ground fault is applied

Bed was connected to the utility grid with approximately 51kW at Meter 2. A simulated overload fault (i.e., Overload Load Bank of 28.3kW on A-phase) with a duration set for 10 seconds was initiated to Zone 4 from the DAS Load Control Program. Figure 10d shows when the overload bank was initiated and load in Zone 4 increased from approximately 52kW to 75kW three-phase power and approximately 17.5kW to 41kW on A-phase. Also in Figure 10d, you can see where the fault is cleared and the load is reduced to 0kW.

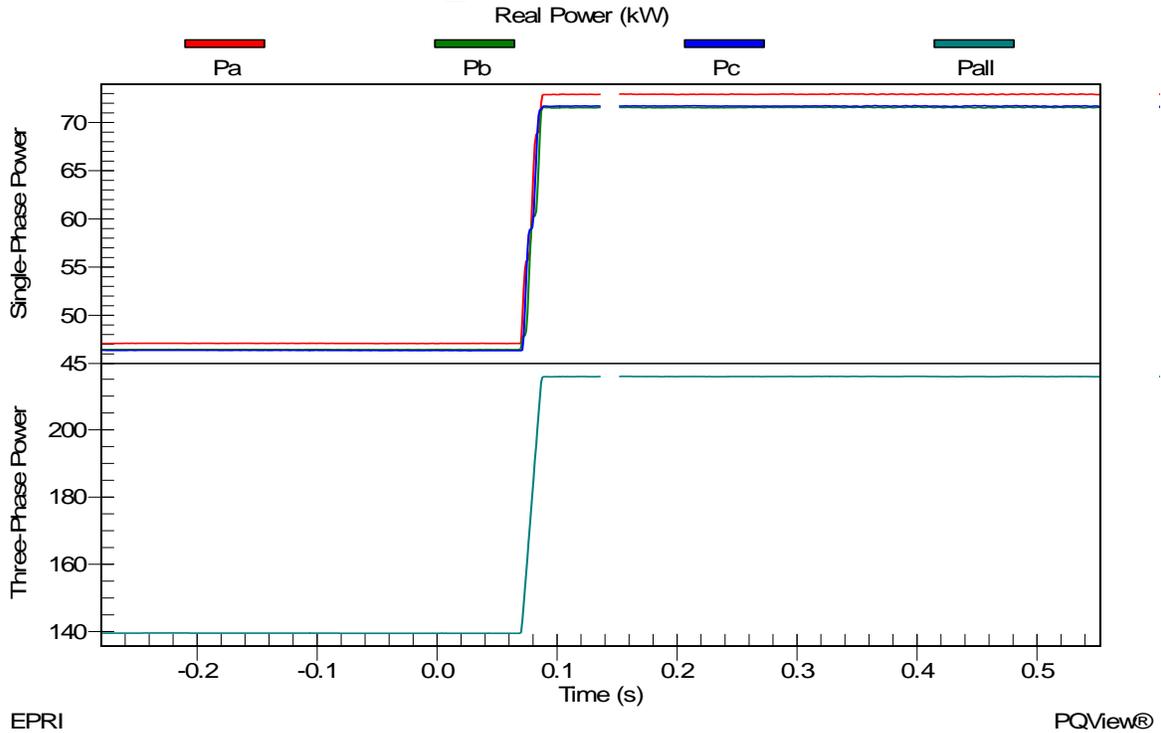
Figure 11a – Load change due to Zone 3 when the overload fault was initiated

Overload load Bank of 85kW was connected by cable/plug into the exterior receptacle of Cabinet 3a. This additional 85kW of load in Zone 3 when initiated would cause an overload in Zone 3, because load is currently set at 75kW in Load Bank 3 and in Load Bank 4.

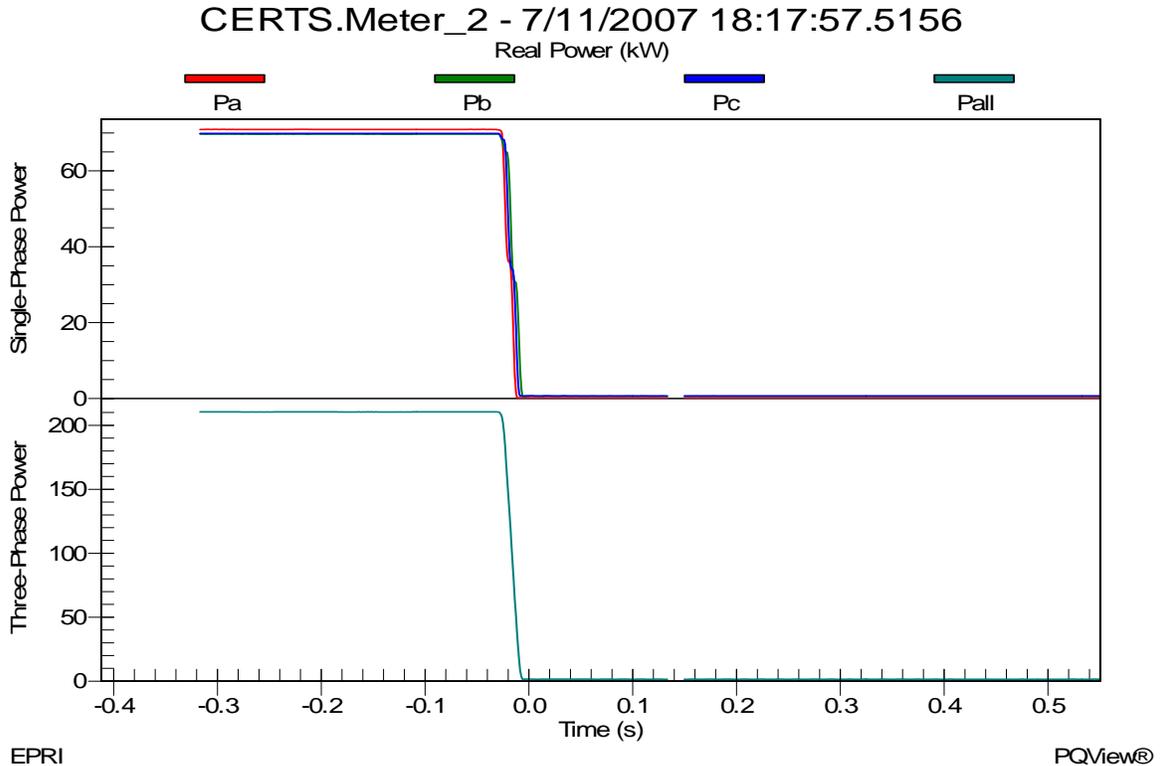
Figure 11b - Load change in Zone 3 after CB31 opened" to isolate and clear the fault

When the load increased in Zone 3, CB31 internally detected an I^2t protection event and opened after 84 seconds, clearing the fault from Zone 3, as shown in Figure 11b.

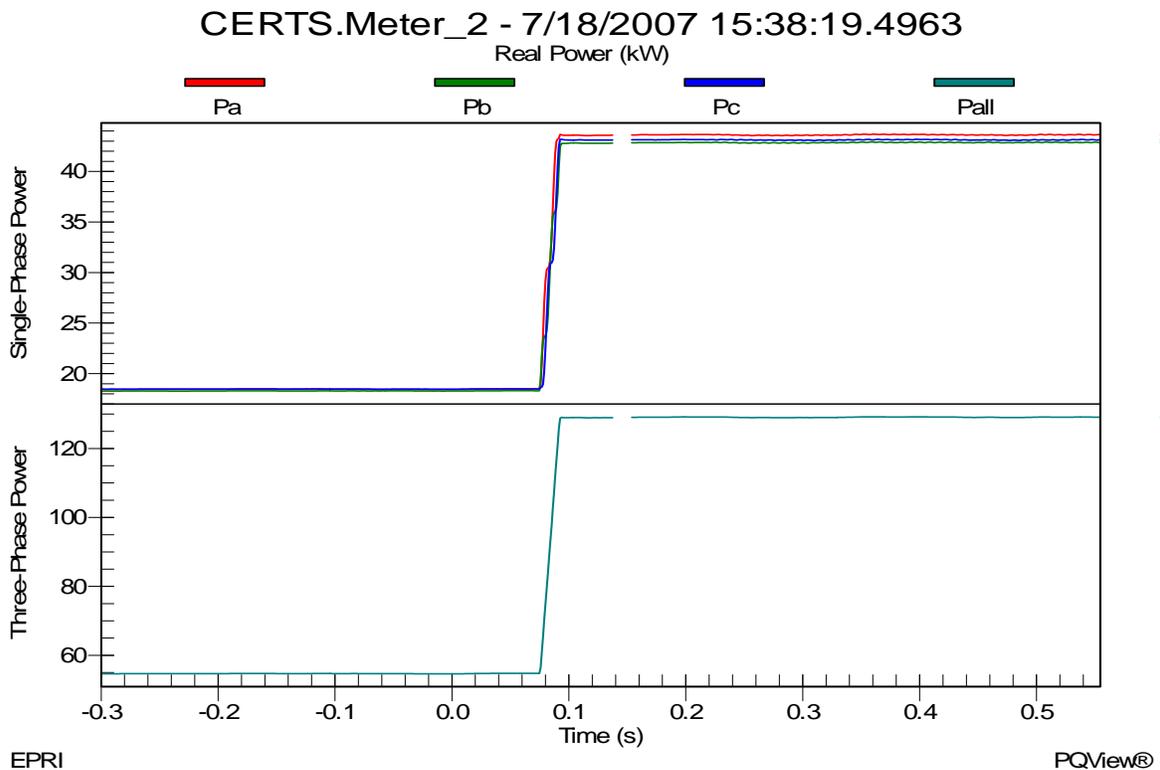
Figure 12a - Load change when the overload fault was initiated in Zone 5.

Bed was connected to the utility grid with approximately 55kW at Meter 2. A simulated fault (i.e., Overload Load Bank of 85kW) with the duration set for 99 seconds was initiated in Zone 5 from the DAS Load Control Program. Figure 12a shows when the overload bank was initiated and load in Zone 5 increased from approximately 55kW to 130kW.

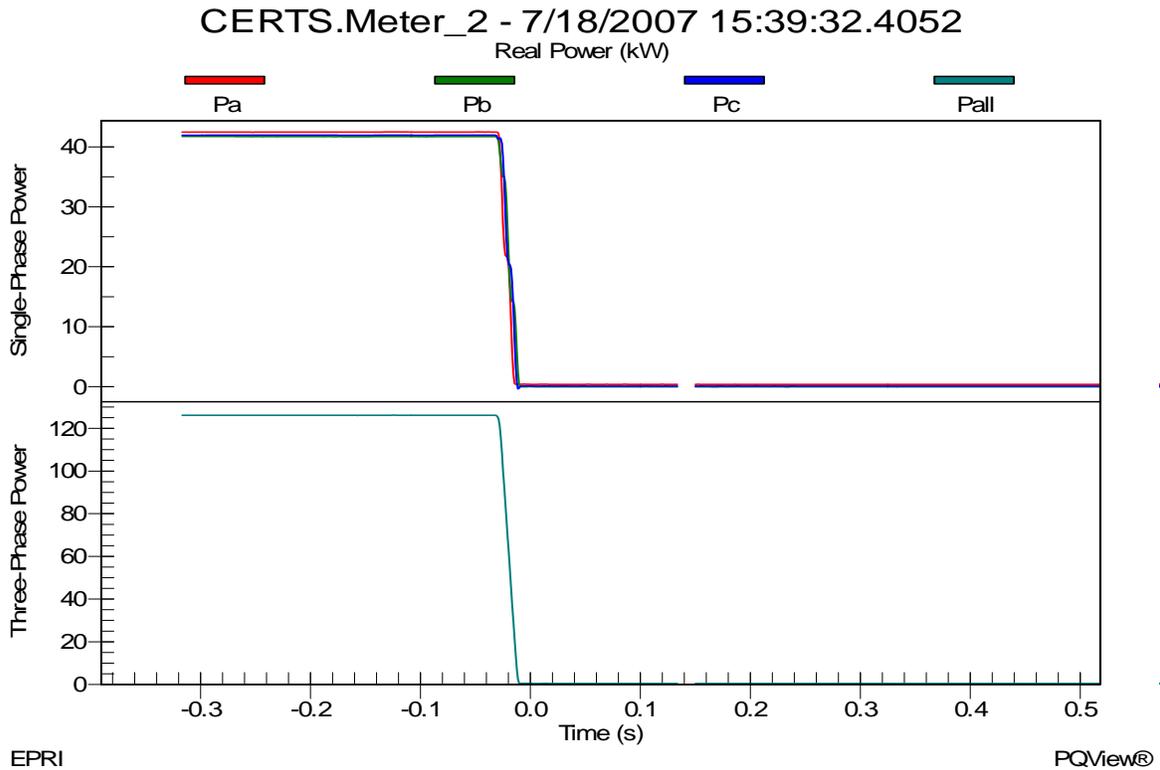
Figure 12b - Load change before/after CB51 opened to isolate and clear the fault in Zone 5.

When the load increased in Zone 5, CB51 internally detected an I²t protection event and opened after 72.8 seconds, clearing the fault from Zone 5, as shown in Figure 12b.

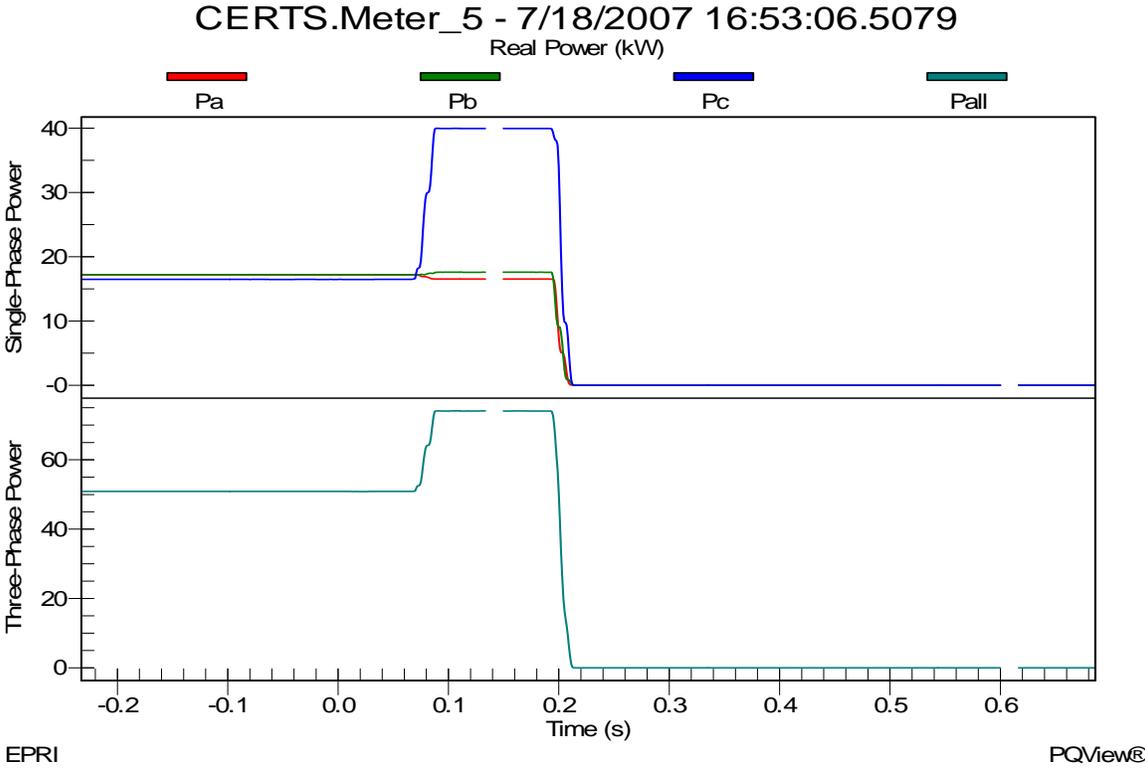
Figure 12c - Load in Zone 5 before/after the single phase-to-ground fault was applied.

Bed was connected to the utility grid with approximately 54kW at Meter 2. A simulated fault (i.e., Overload Load Bank of 28.3kW on C-phase) with a duration set for 10 seconds was initiated to Zone 5 from the DAS Load Control Program. Figure 12c shows when the overload bank was initiated and the load in Zone 5 increased from approximately 51kW to 74kW three-phase power and approximately 16.5kW to 40kW on C-phase. Also, Figure 12ce, shows where the fault is cleared and the load is reduced to 0kW.

When the load increased in Zone 5, Relay 5 detected a negative-sequence over-current (67Q1T) event, shown in Figure 12f. CB51 opened and cleared the fault from Zone 5 shown in Figure 12f. The opening of CB51 was past the end of the recorded relay waveform, but it can be seen that the real power at Meter 5 reduces to zero, shown in Figure 12c.

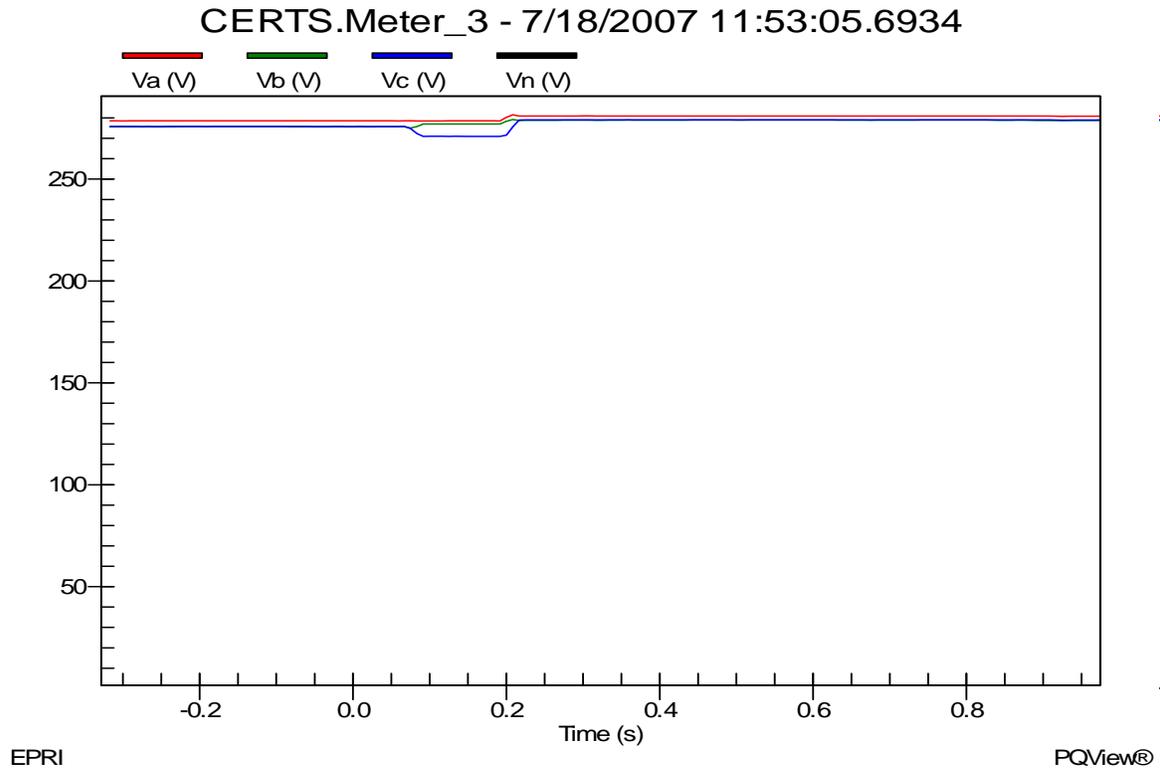
Figure 12e - RMS Voltage in Zone 3 before/after the single phase-to-ground fault was applied

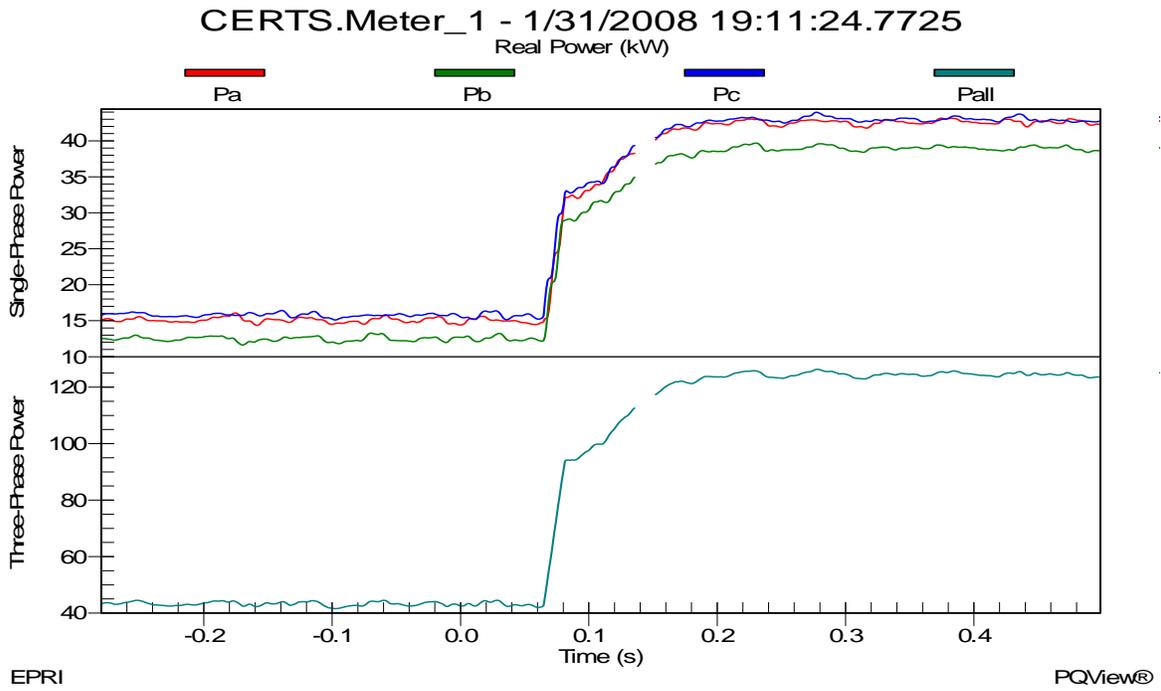
Figure 13a - Power flow at Meter 1 before/after the overload fault was applied.

overload fault was applied in Zone 4, the load increased from 45kW to approximately 125kW at Meter 1.

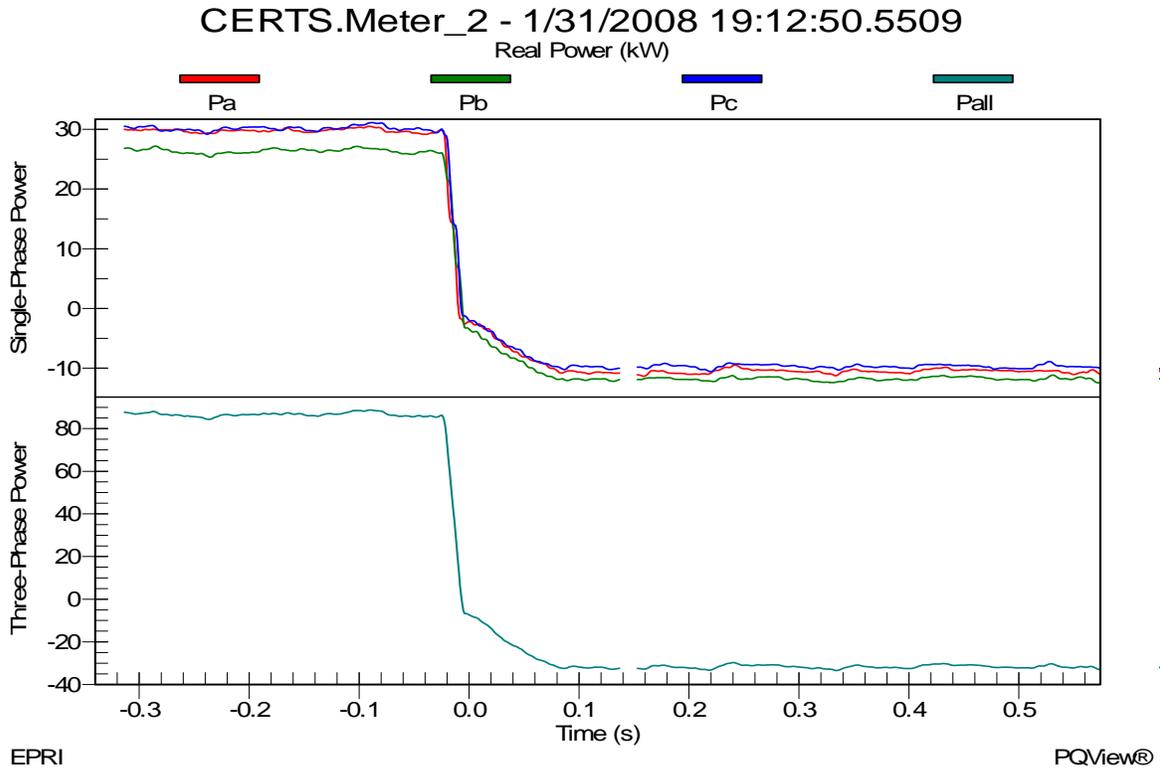
Figure 13b - Power flow at Meter 2 before/after CB41 opened.

Using the DAS Load Control program, the three-phase ground fault was set for a duration of 99 seconds and then initiated. CB41 tripped on an I²t protection event in 86 seconds, shown in Figures 13b, which isolated and cleared the fault as expected in Zone 4. Zone 3 and Gen-set A1 remained connected, displacing the load in Zone 6, as shown in Figure 13b with minus 37kW through the static switch. This results in approximately zero load at the PCC, which in-turn caused the static switch to open after 30 seconds due to a reverse power event.

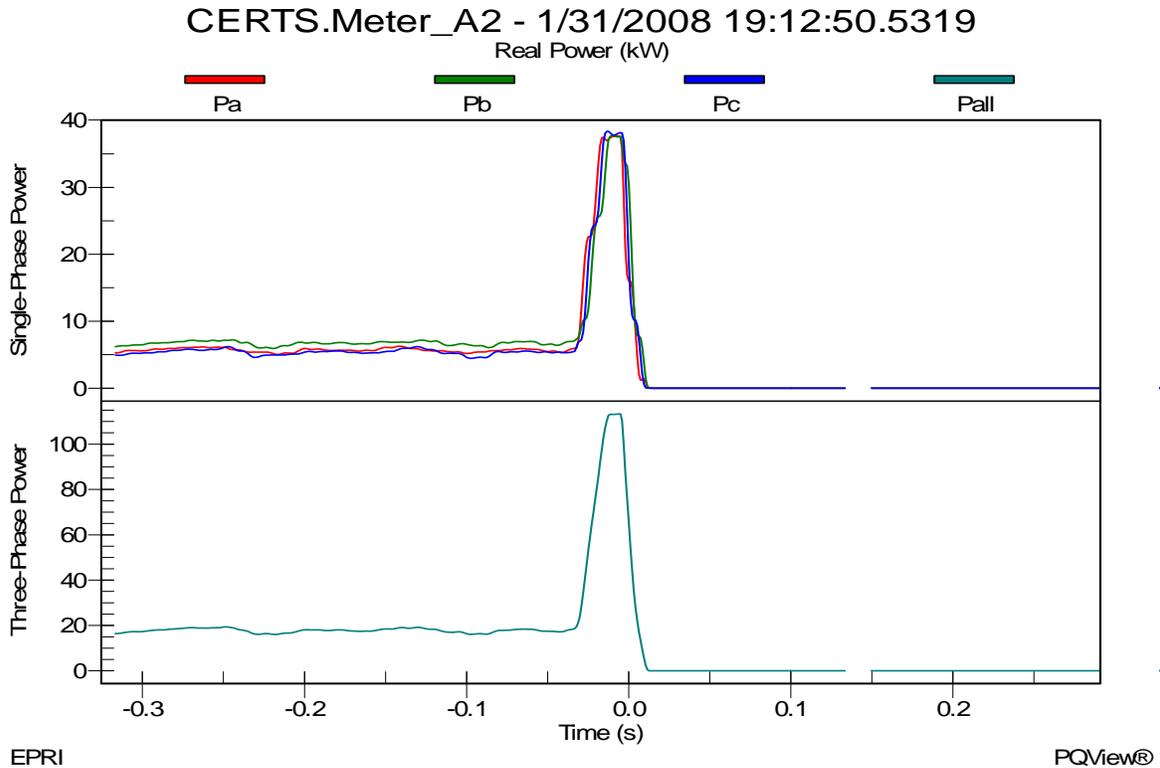
Figure 13c - Gen-set A2 shutting down after CB41 opens

from the microgrid. Since Gen-set A1 was set for a Unit Power Control of 50kW and there was only 10kW worth of load from Load Bank 3 within the microgrid a reverse power flow occurred opening the static switch islanding it from the utility grid. The static switch opened approximately 56.2 seconds after CB41 opened and Gen-set A1 remained online, serving the microgrid load. Figure 13e shows Gen-set A1 picking up the load from Load Bank 3, approximately 12kW after the static switch opened.

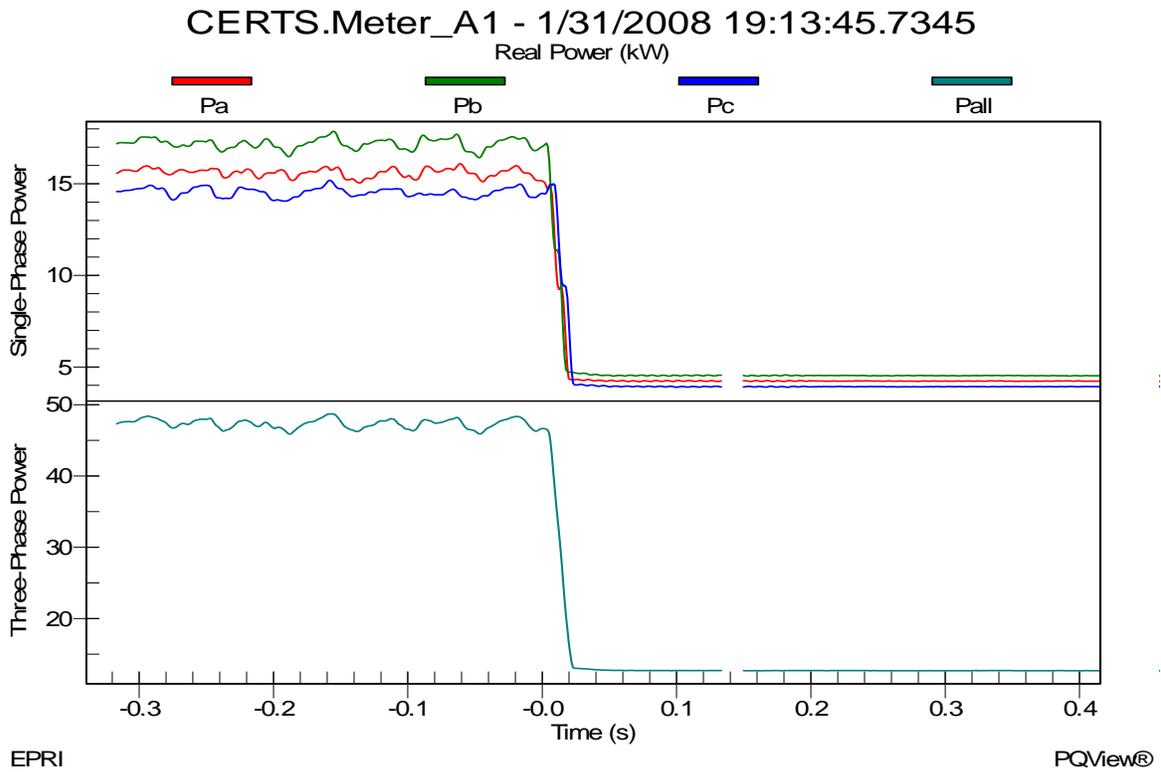
Figure 13e - Gen-set A1 power flow reducing its output power to approximately 12kW after the static switch opens from a reverse power condition.

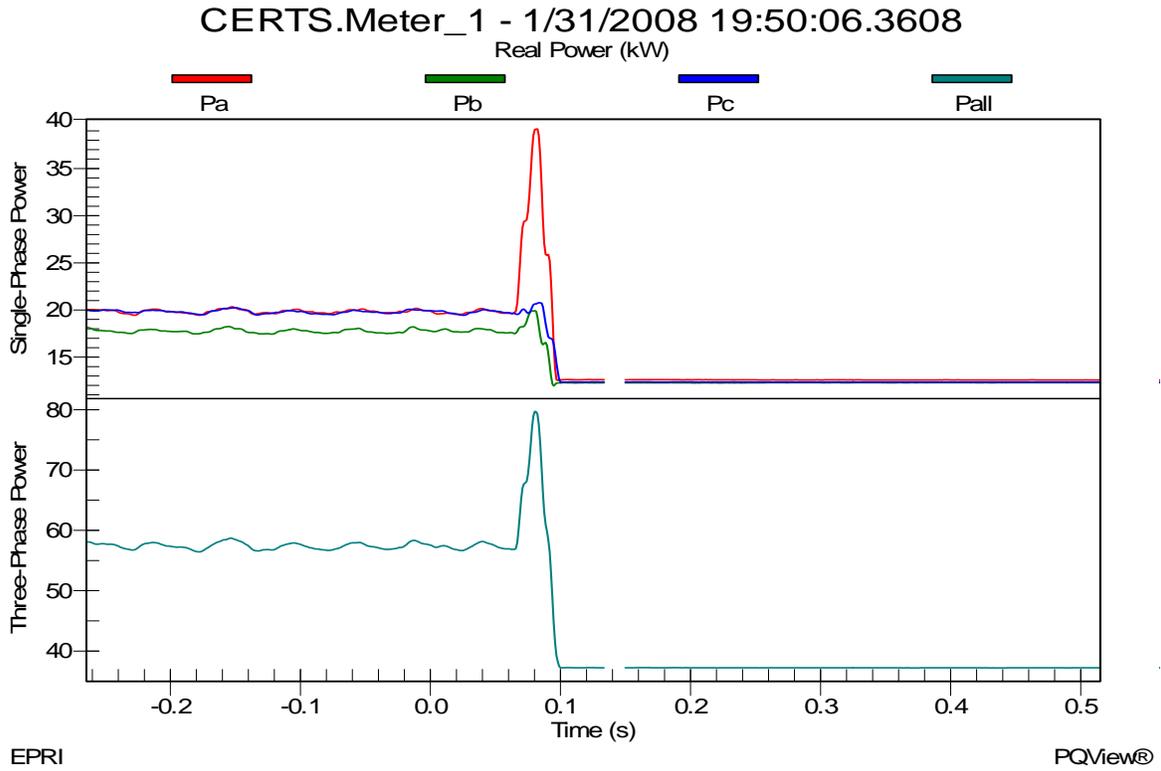
Figure 14a - Power flow in Meter 1 before/after the fault was cleared in Zone 3.

closed and steady-state conditions established, the microgrid and Load Bank 6 were connected to the utility grid with the total power flow at Meter 1 equaling approximately 57.5kW, shown in Figure 14a, and 21kW at Meter 2 shown in Figure 14b before the fault was applied.

Using the DAS Load Control program, the single phase-to-ground fault on A-phase was set for 10 seconds and then initiated. The static switch tripped first in approximately 0.016 seconds (~1 cycle) from a ground over-current (67N1T), shown in Figure 14c, isolating the microgrid from the utility grid. Relay 3 tripped CB31, opening in 0.15 seconds (~9 cycles) after the static switch opened due to a ground over-current (67N1T), shown in Figure 14d, isolating Zones 3 and 4 from the rest of the microgrid and shutting down Gen-set A1. It is also worth noting that once the static switch opens the phase currents measured by the relay reduce to zero. However, because of the grounding layout, ground current from the fault, fed by Gen-set A1, is still measured and tripped. Once CB31 opens Zones 3 and 4 are isolated, no longer being satisfied by the grid or Gen-set A1 as shown by the collapsed voltage in Figure 14d. The approximate 39kW load in Load Bank 6 is still being satisfied by the grid as shown in Figure 14a.

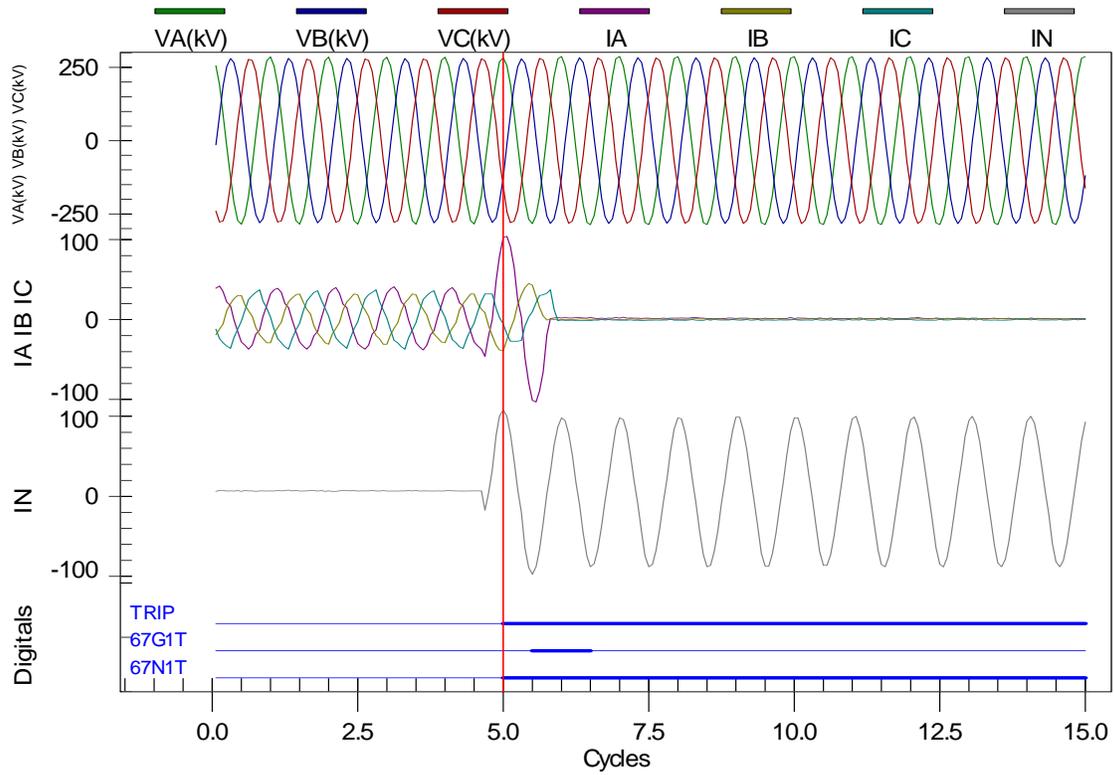
Figure 14c - Relay 2 (static switch) tripped due to ground over-current (67N1T) in 1 cycle after the single phase-to-ground fault was applied in Zone 3.

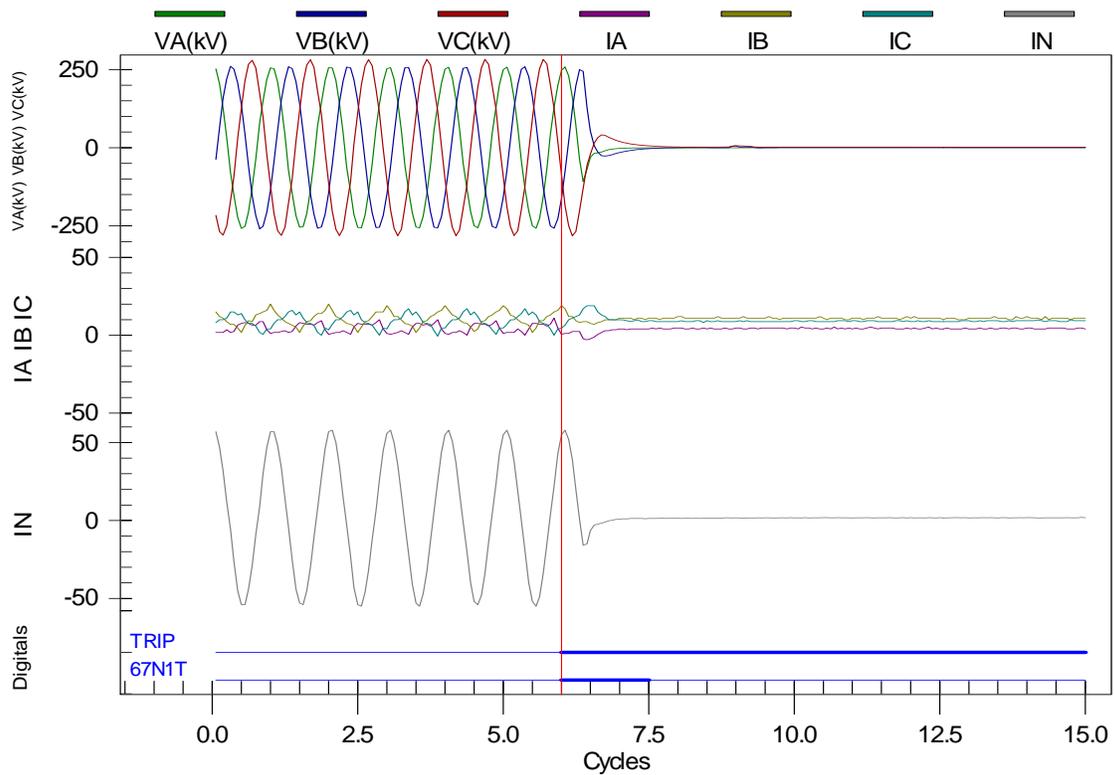
Figure 14d - Relay 3 (CB31) tripped on a ground over-current (67N1T) after the single phase-to-ground fault was applied in Zone 3.

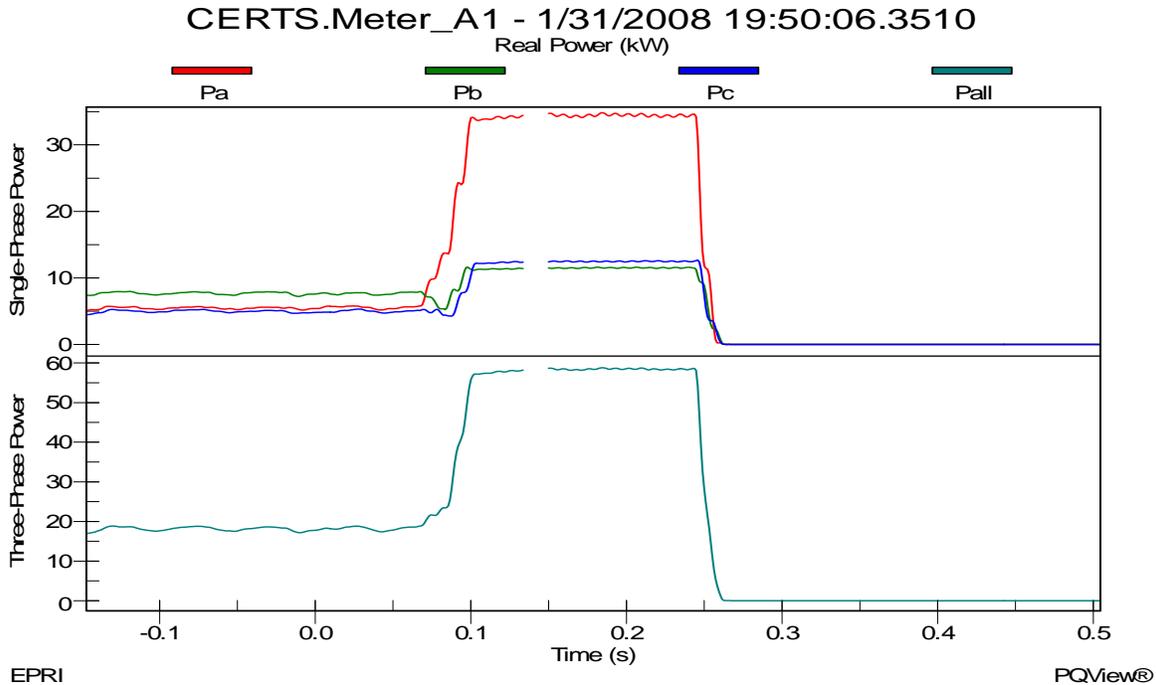
Figure 14e - Gen-set A1 output power before/after the static switch opens and then when Zones 3 and 4 are isolated from the rest of the Microgrid.

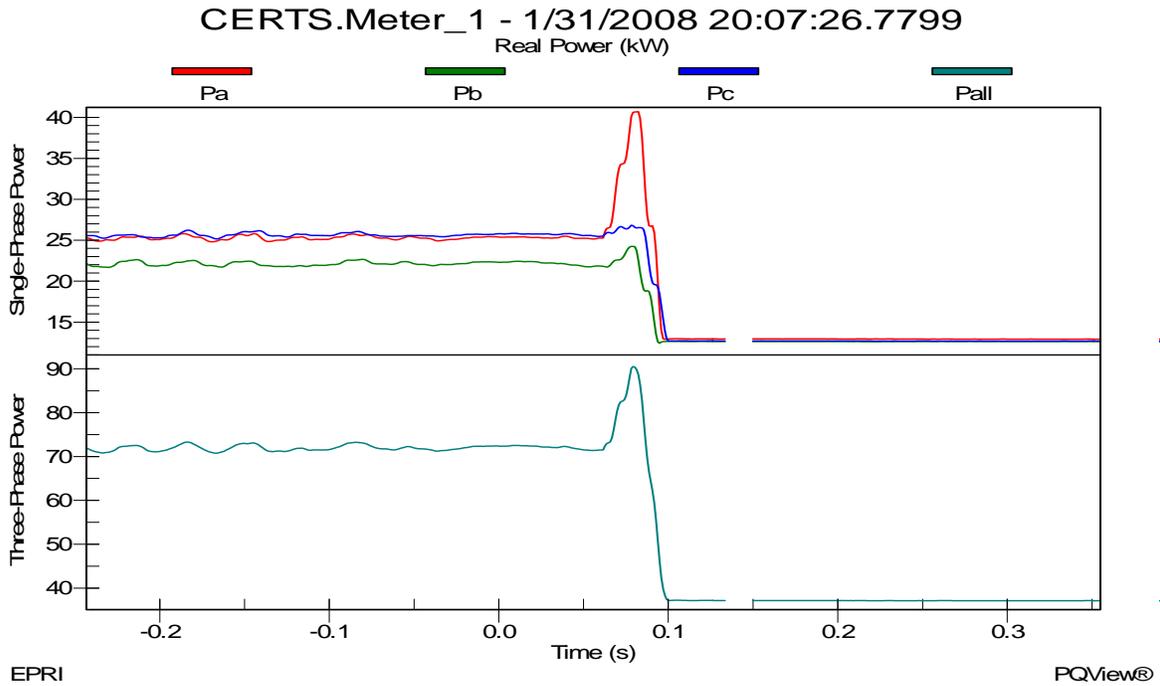
Figure 15a - Meter 1 power flow before/after the static switch opens, islanding the microgrid from the utility grid after a single phase-to-ground fault was applied to Zone 3.

After both Gen-sets A1 and A2 were running for a few minutes and supplying power to Load Banks 3 and 4, the test was started with a "Start" command from the EMS. As soon as the static switch closed and steady-state conditions established, the microgrid and Load Bank 6 were connected to the utility grid. Before the fault was applied the total power flow at Meter 1 was approximately 72.5kW shown in Figure 15a and approximately 35kW at Meter 2 shown in Figure 15b.

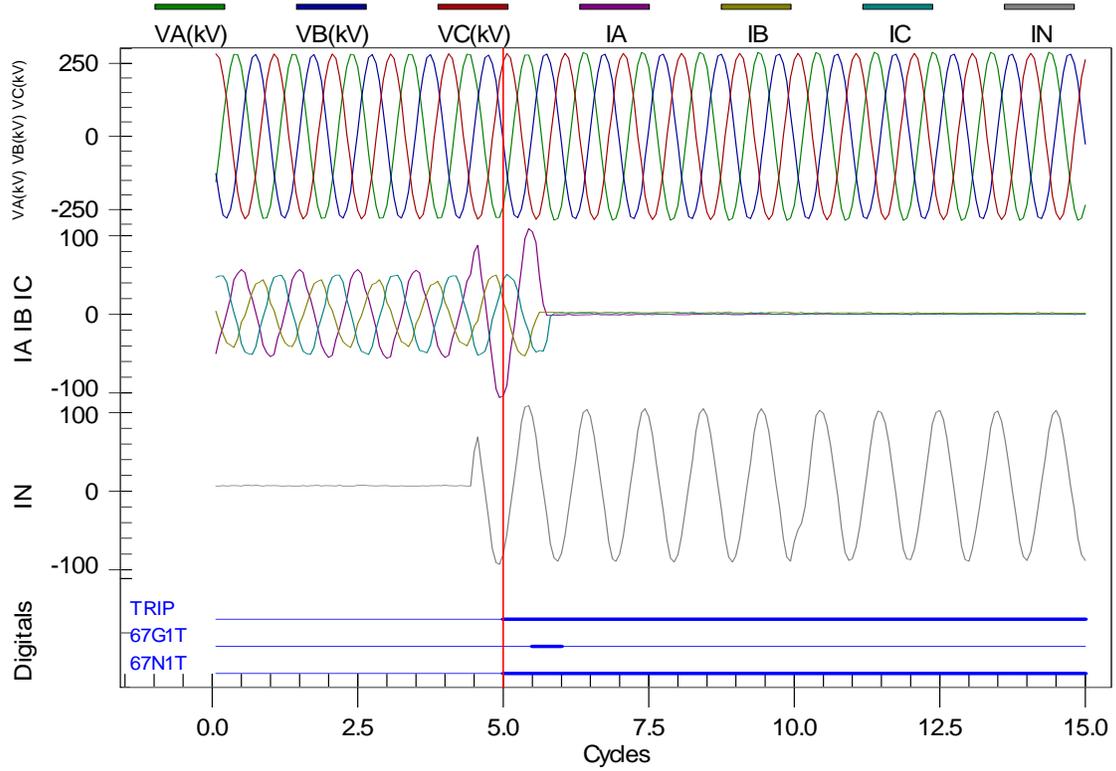
Figure 15c - Relay 2 (static switch) tripped after the single phase-to-ground fault was applied in Zone 3.

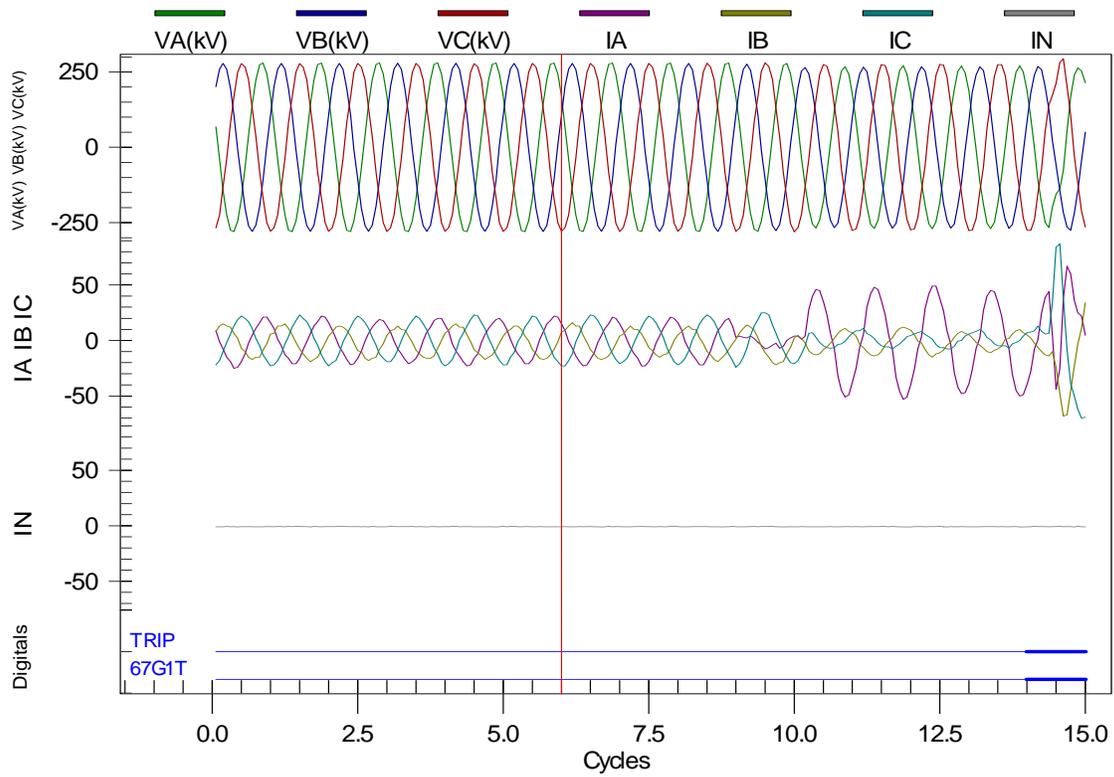
Figure 15d - Relay 4 (CB41) tripped after the single phase-to-ground fault was applied in Zone 3.

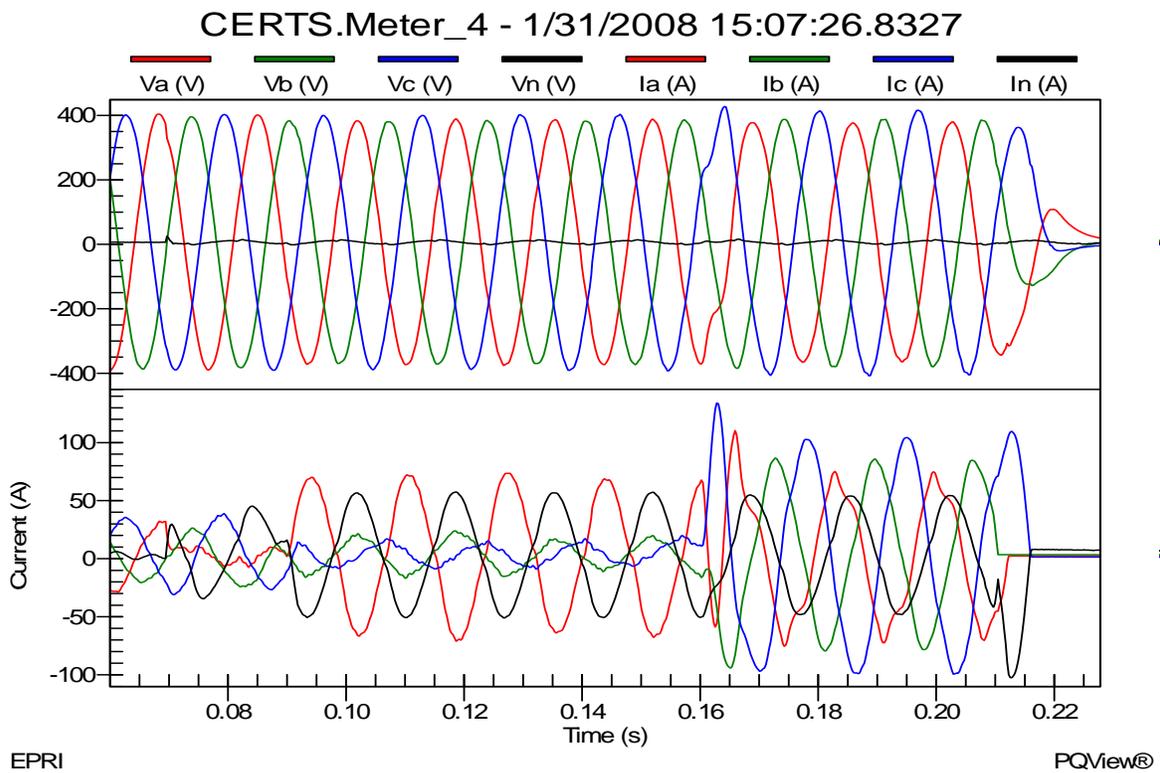
Figure 15e - Meter 4 (CB41) voltage and current for a single phase-to-ground fault applied in Zone 3.
 A complex situation took place in Figures 15e, 15f and 15g. The fault was applied at 0.07 seconds which caused the static switch to open at 0.09 seconds. This was followed by a short period where both Gen-sets A1 and A2 were supporting the microgrid load, as well as the fault overload, shown in Figures 15f and 15g between 0.09 and 0.16 seconds. At 0.16 seconds Relay 4 commanded Gen-set A2 to shutdown and CB41 to open. Gen-set A2 first stopped delivering power to the microgrid, as seen by the sudden increase of current at Meter 4, Figure 15e, and Meter A1, Figure 15g. Even though Gen-set A2 stopped switching the inverter output, its interface transformer remained connected to the microgrid. This is evident by the continued current flow though Meter A2 after 0.16 seconds, Figure 15f, due to the Wye/Delta transformation, and also evident in the real power transferred from B and C phases to A phase at Meter A2 in Figure 15h. At 0.215 seconds CB41 opened reducing the current through CB41 to zero and denergizing Zone 4 of the microgrid.
